## **Touch Screen Powers on White**

**Product:** IMAX Touch Panoramic

**Required Action:** Remote Check, Onsite Check, Replacement of Parts

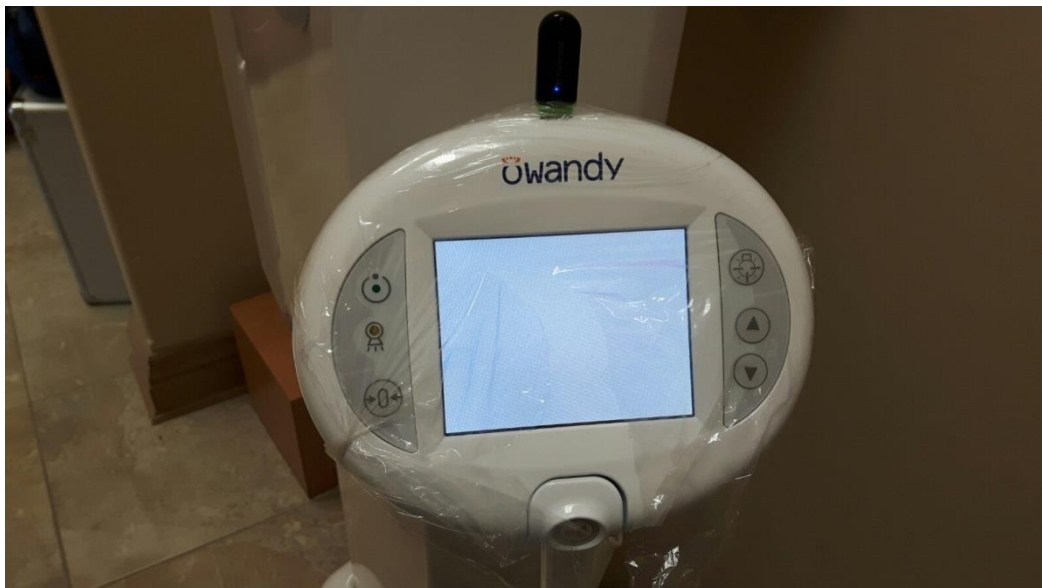
When the Pano is powered on, the master control touch screen remains completely white and does not proceed to machine setting phase after 20-30 seconds of waiting

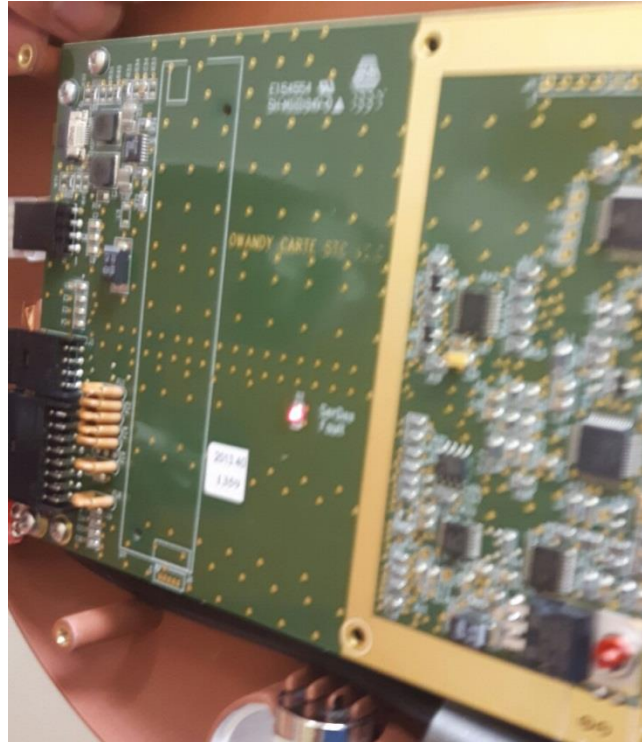
If white touch is ALWAYS present during power on, regardless of sensor(s) being disconnected, try following the power on procedure from the PC with digital GUI opened. After a minute, press >0< button on the master control to see if machine does it's check and if the GUI capture module on PC connects. Try also to ping the machine IP address. If you have a reply, try to capture a image via PC. If you can capture an image with the white screen present, problem is with DSPU to LCD Touch Screen cable or LCD Touch Screen control board itself; a technician can remove covers and check for Fault LED lit on the back of LCD Touch Board (see below).
